Manhole Inspection Summary

Manhole # S19I__019MH

Insp Date: **9/28/07 9:04 AM**

Location Address: **2103 FREDICK AVE**

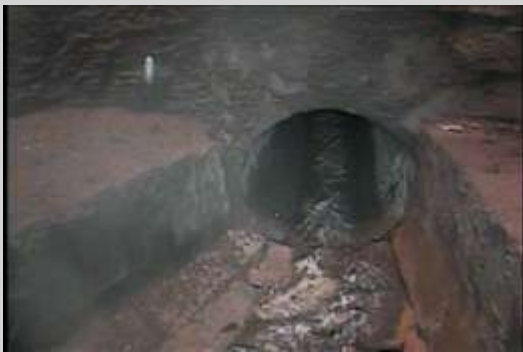
12 O'Clock Outflow

8 in. Circular Gravity Sewer
Pipe Out @ 12 O'Clock

Pipe Height: **7.2** (in.) Rod and Bar (Angled)
Pipe Material: **Clay** ☐ Pipe Lined
Invert Depth: **9.80** (ft.) Flow Characteristics: **Slow**
Deposits: ☒ None ☐ Mud ☐ Sludge ☐ Debris ☐ Grease
Silt Depth: (in.) Deposits Extent:
Infiltration: **None** Pipe Seal Cond: **Sound**

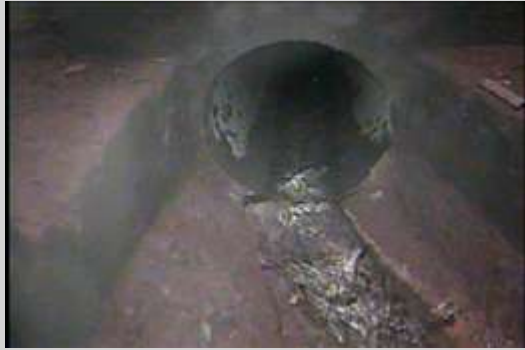
8 O'Clock Inflow

8 in. Circular Gravity Sewer
Pipe In @ 8 O'Clock

Pipe Height: **8.4** (in.) Rod and Bar (Angled)

Pipe Material: **Clay** ☐ Pipe Lined

Infiltration: **None** Pipe Seal Cond: **Sound**
